725HF-SS and 725HF-A Piston Valves

Maintenance & Parts Guide

Valve Disassembly and Reassembly Procedures

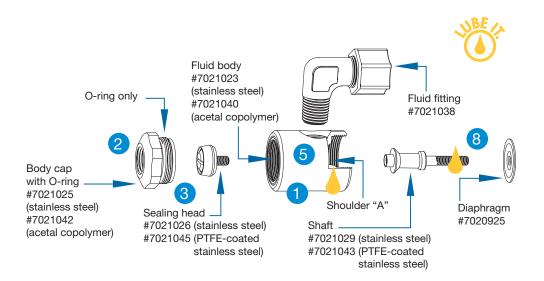
- **1.** Put threaded rod in mounting hole.
- 2. Remove body cap.
- 3. Remove sealing head. *
- 4. With a wrench on the flats of the air cylinder body, turn to loosen fluid body.
- 5. Remove fluid body. *
- 6. Remove input air hose from push-in fitting on air cap.
- Insert 1/8" hex wrench through air inlet hole in cap and turn shaft, locking screw out two turns. *

- Using the hex on the shaft, unthread shaft, and remove shaft and diaphragm. *
- Unscrew air cylinder cap from air cylinder body. *
- **10.** Remove piston and spring.

Reassemble the valve in reverse order of disassembly. Lubricate parts indicated with Nye Lubricant #865 included in the General Maintenance Kit.

step	part	newton meters	(inch pounds)
3	Sealing head screw	1.69 Nm	(15 inch pounds)
5	Stainless steel fluid body	10.8 - 13.6 Nm	(8 - 10 foot pounds)
5	Acetal fluid body	.033 Nm	(.30 inch pounds)
7	Shaft locking screw	2.82 Nm	(25 inch pounds)
8	Shaft	1.69 Nm	(15 inch pounds)
9	Air cylinder cap	10.8 Nm	(8 foot pounds)

*Parts that require a specific torque when reassembling the valve.

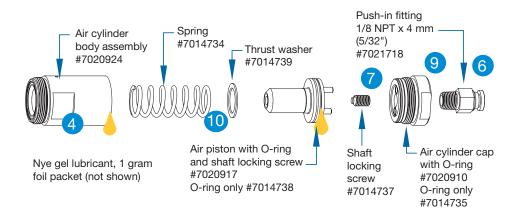
725HF-SS assembly of piston, diaphragm and shaft.
